SPECIAL REPORT

FLOOD OF MARCH 2, 1938, IN REGION 10

SOUTHERN CALIFORNIA

SUBJECT Operation of Flood  
Control Structures, Storm of  
March, 1938.

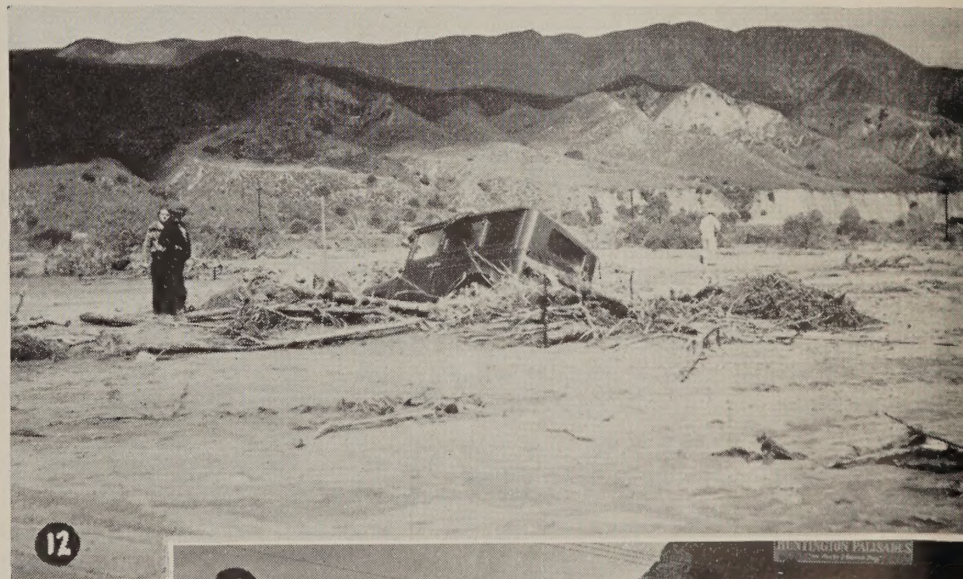
12

12. The Big Tujunga Wash which crosses the route of State Highway 9 near Sunland wreaked destruction on roads and bridges.
13. Embankment was washed out together with half the Newhall-Saugus highway when a creek became a river.

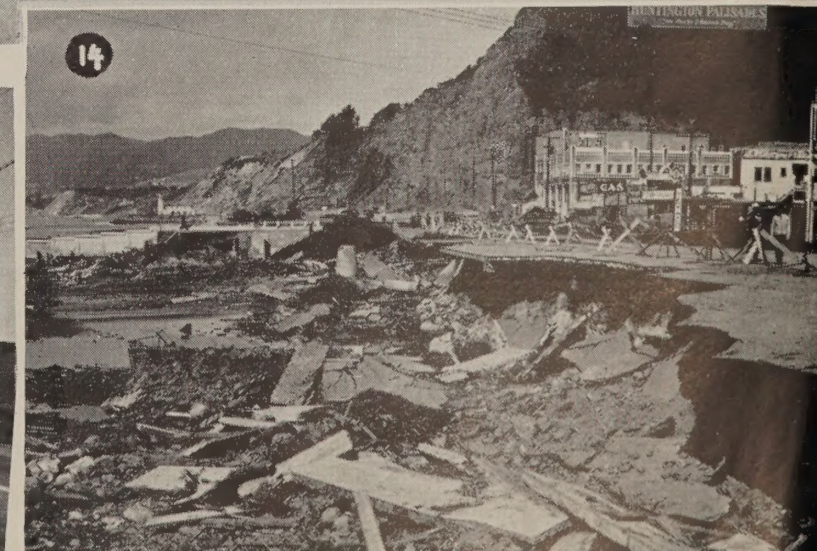
14

14. The flood roaring down Santa Monica Canyon joined with high-ocean waves to undermine the Coast Highway at the canyon's mouth.

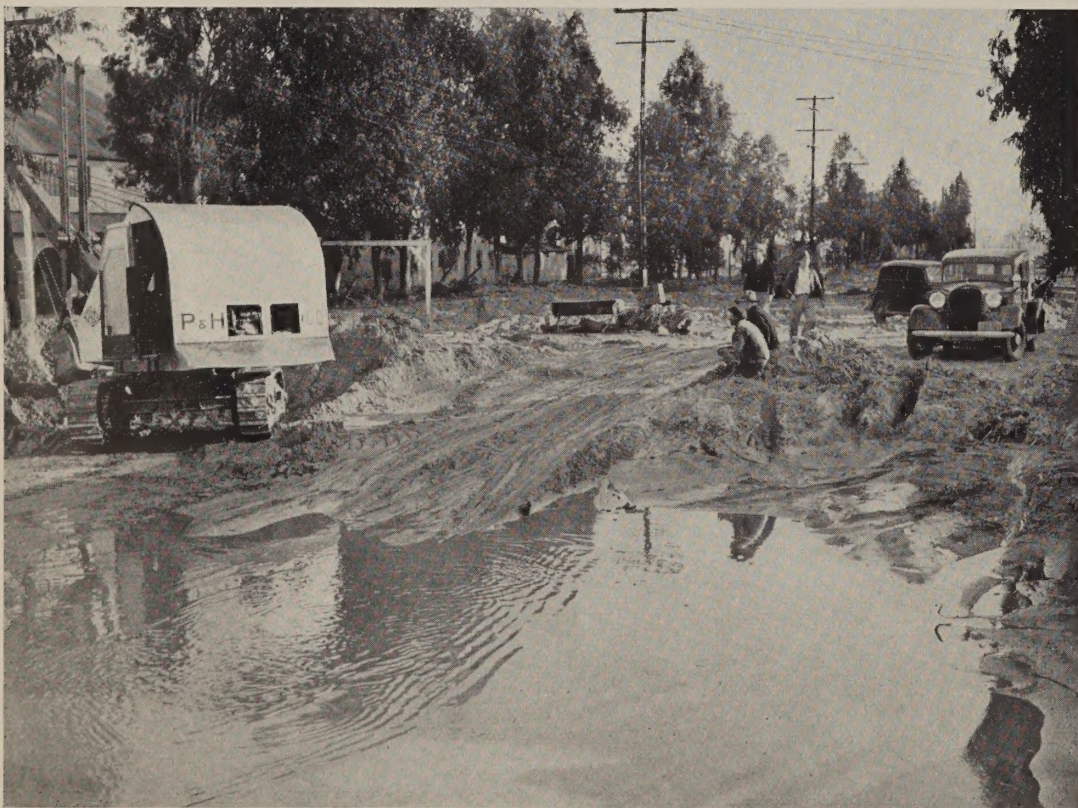
This is how flood left E Street in San Bernardino, a thoroughfare leading to famous Orange Show Pavilion, which can be seen on the left of power shovel removing five feet of mud.

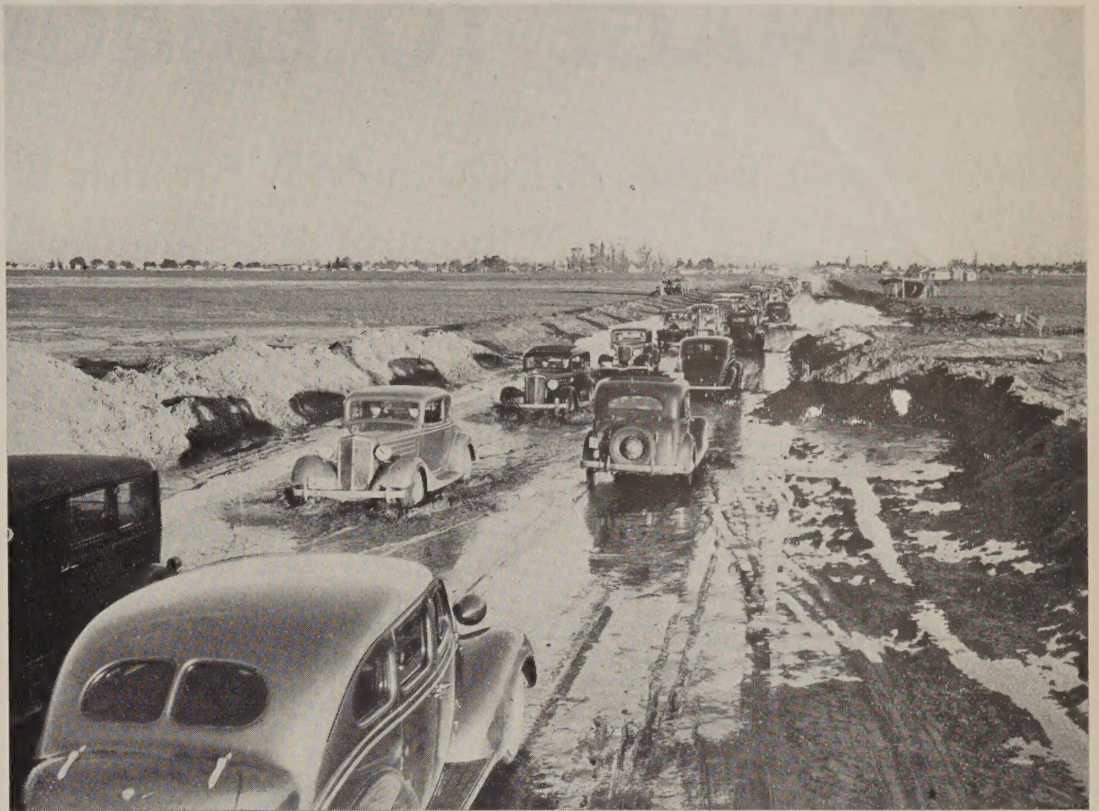
Overflow waters from Coyote Creek left Firestone Boulevard, Los Angeles, looking like this after being cleared of silt.

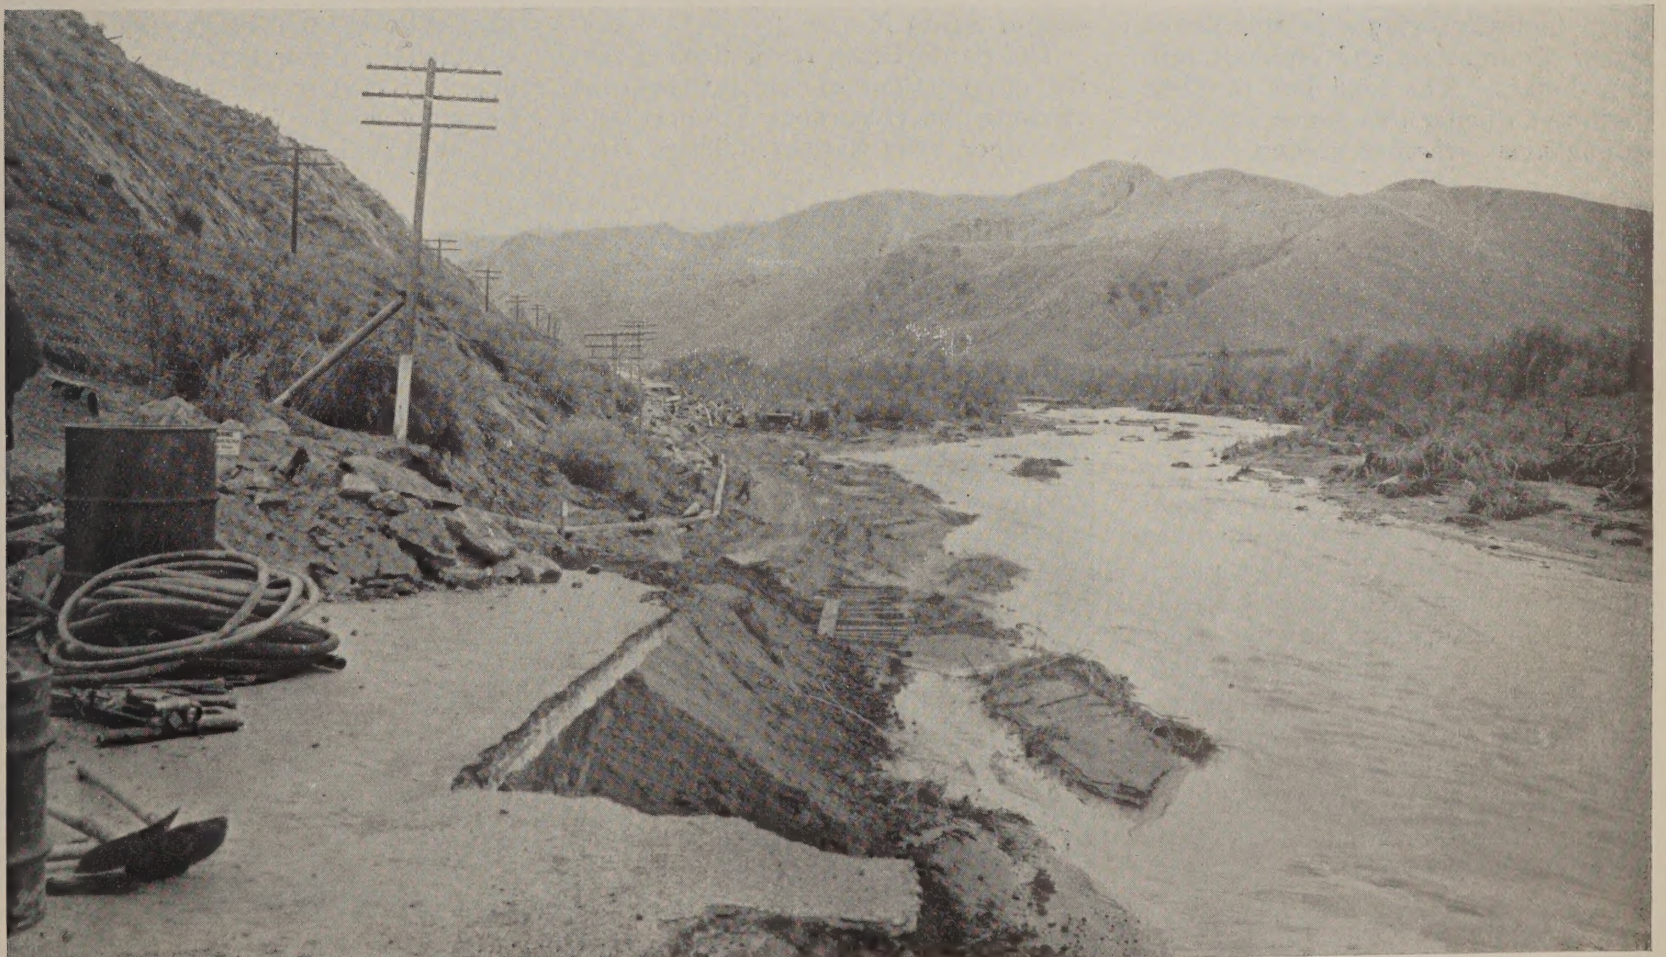
This picture vividly reveals damage wrought by Santa Clara River floods on Ventura-Castaic lateral highway between Piru and Los Angeles County line in Ventura County.

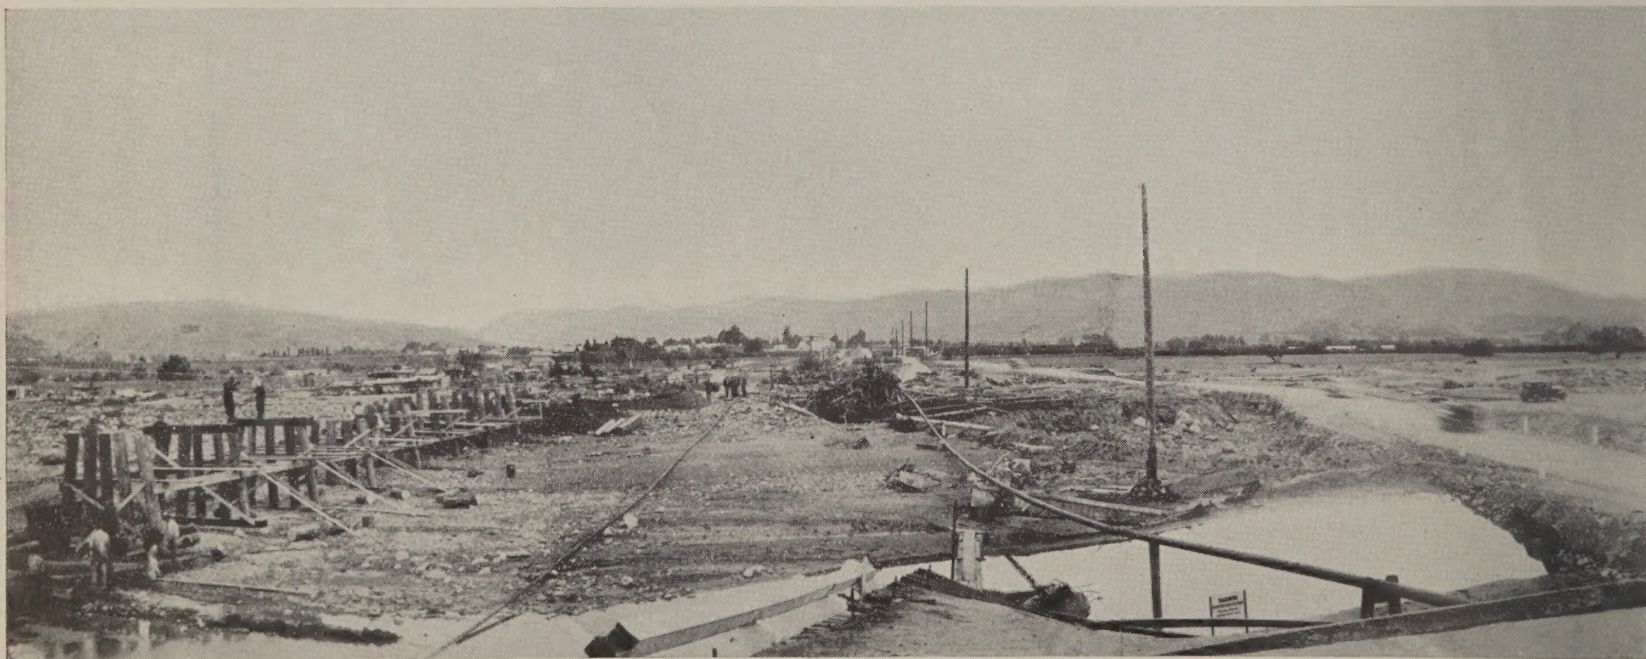
Sespe Creek swollen out of its banks by tributaries in a high mountain area of Ventura County cut a wide swath of damage as it swept across State Highway 79 near Fillmore. A county-built timber and concrete bridge and a paralleling railroad structure were washed away. A large section of highway was obliterated but a detour road shown at right was quickly built and opened.

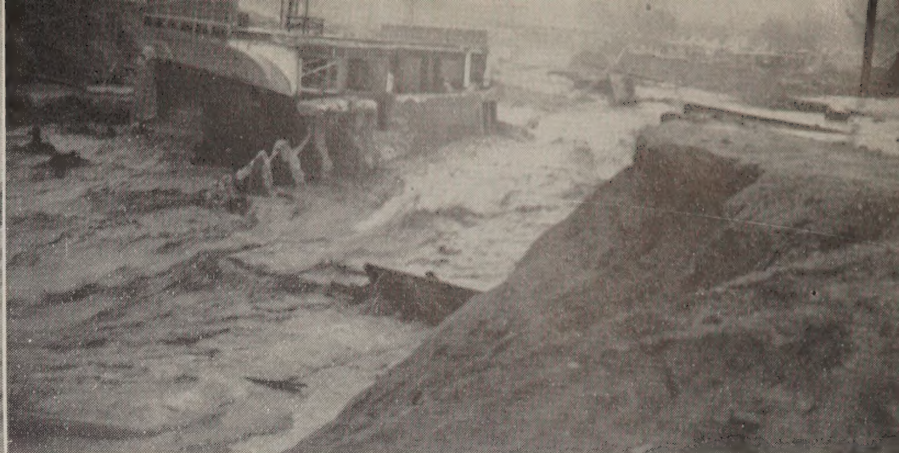
Before and after views of the bridge across Verdugo Creek on State Highway 61 in Los Angeles County. Fed by small tributary streams in the San Gabriel Mountains the creek became a raging torrent that cut a new channel, swept away the bridge approach and damaged the abutment.

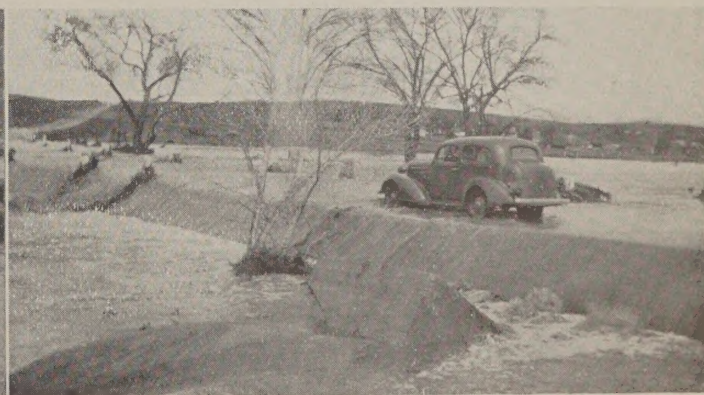
Highway dip washed out by Santa Maria River east of Ramona. Another dip west of Ramona overflowed.

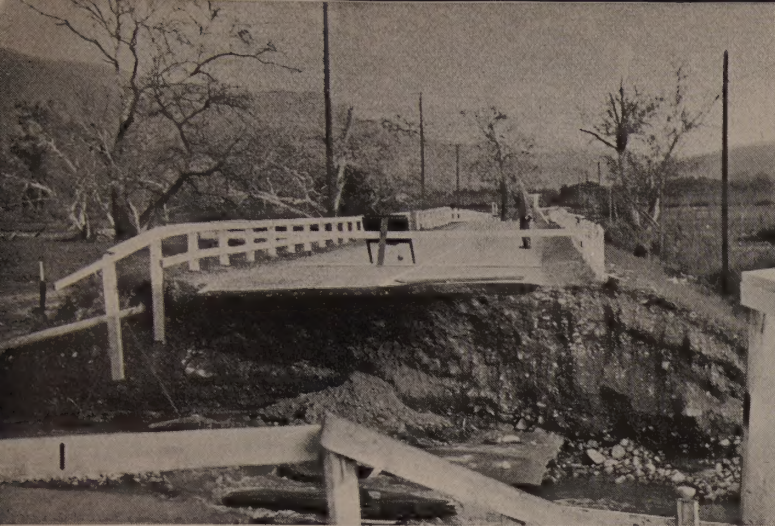
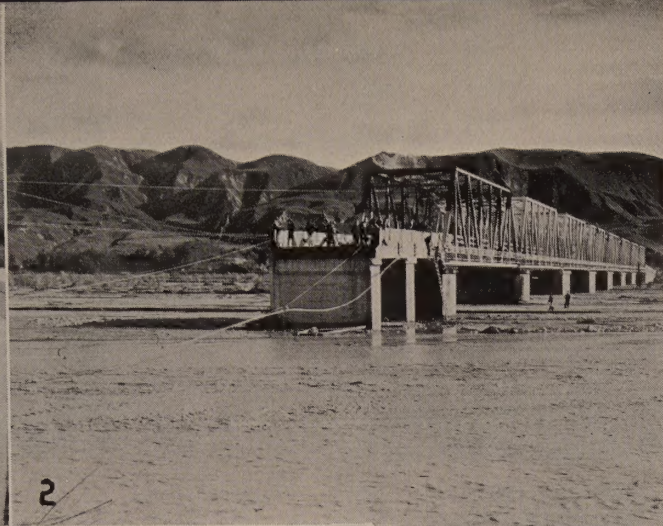
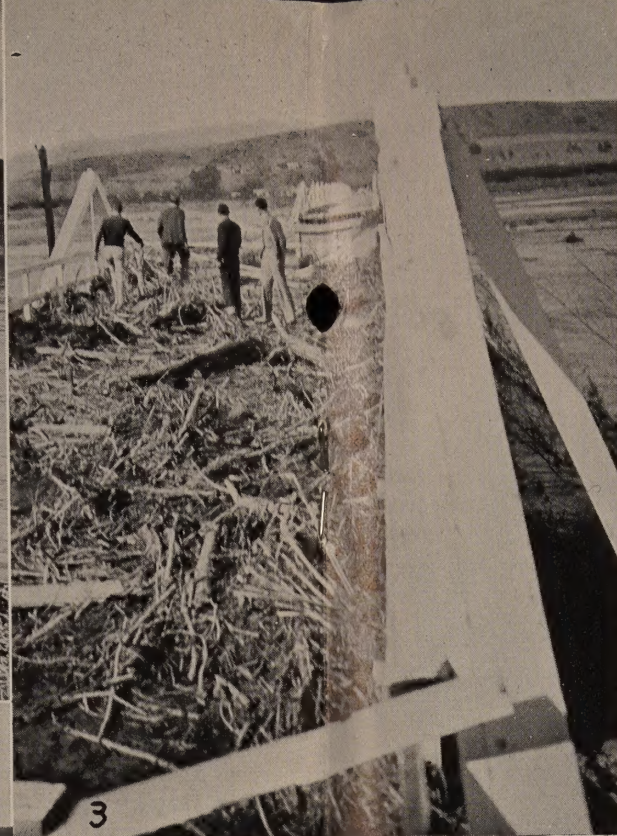
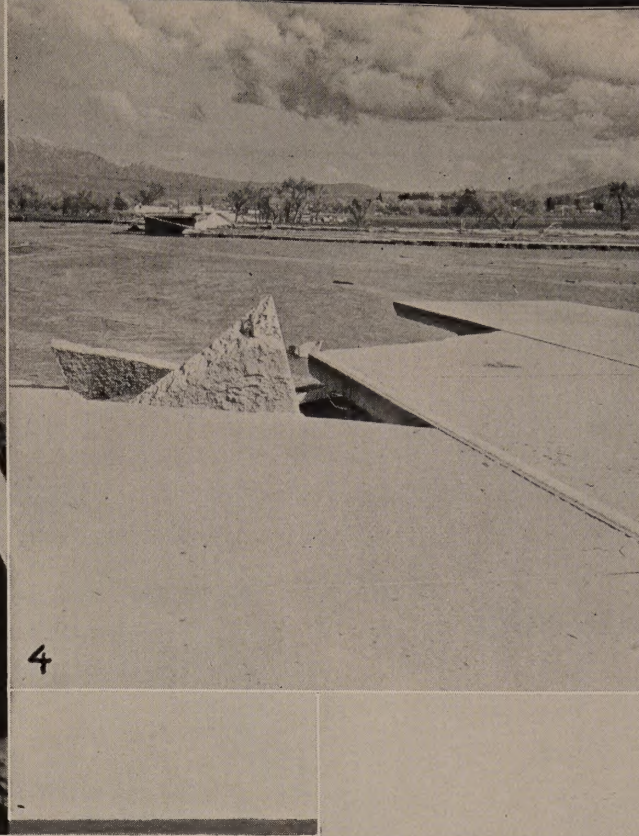
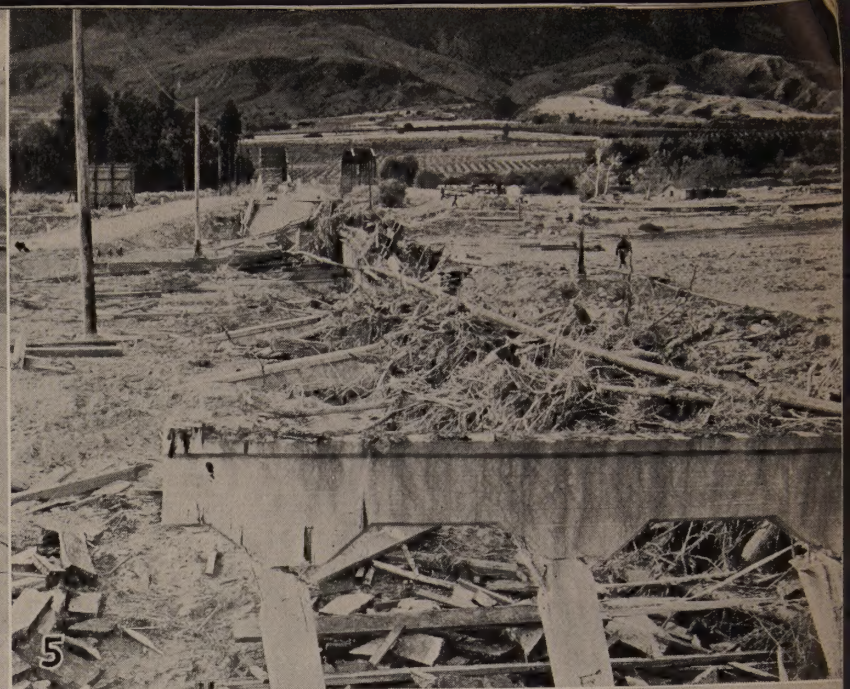
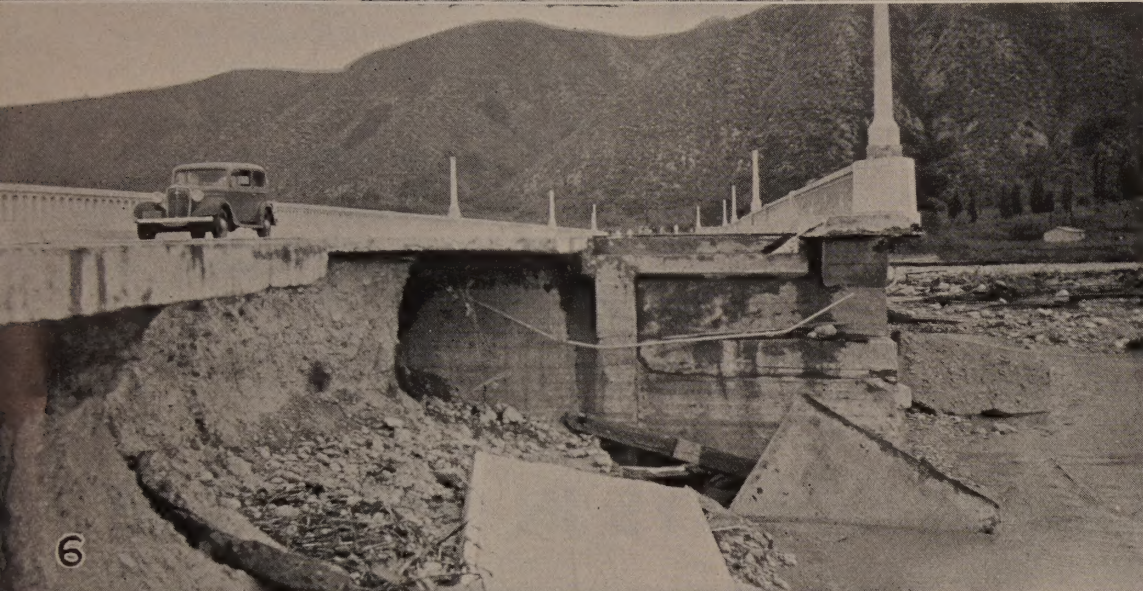
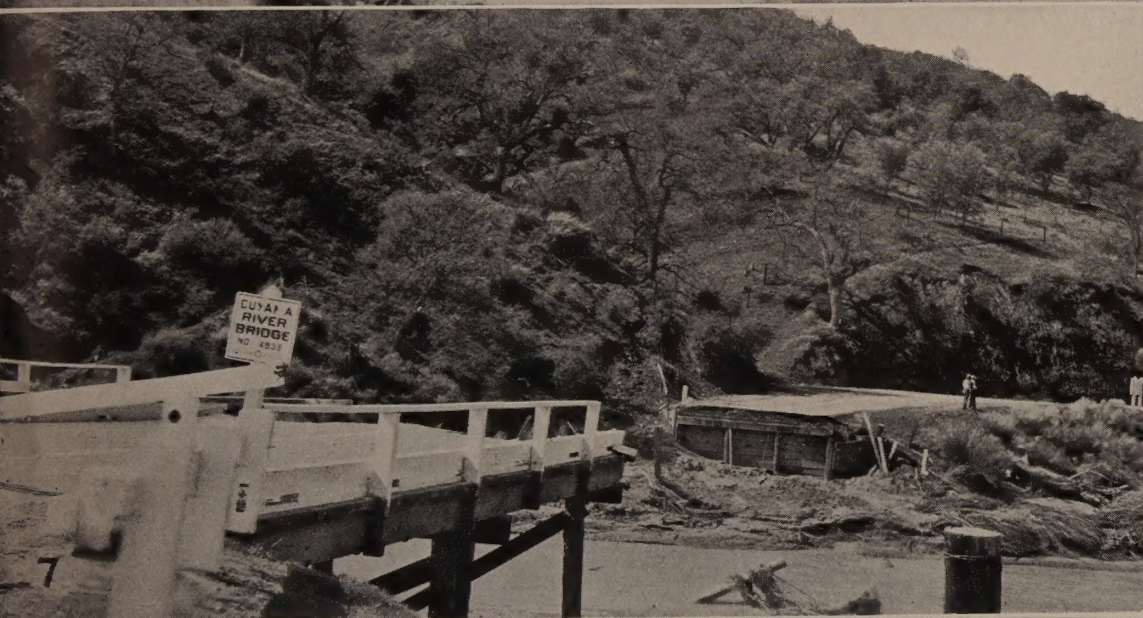
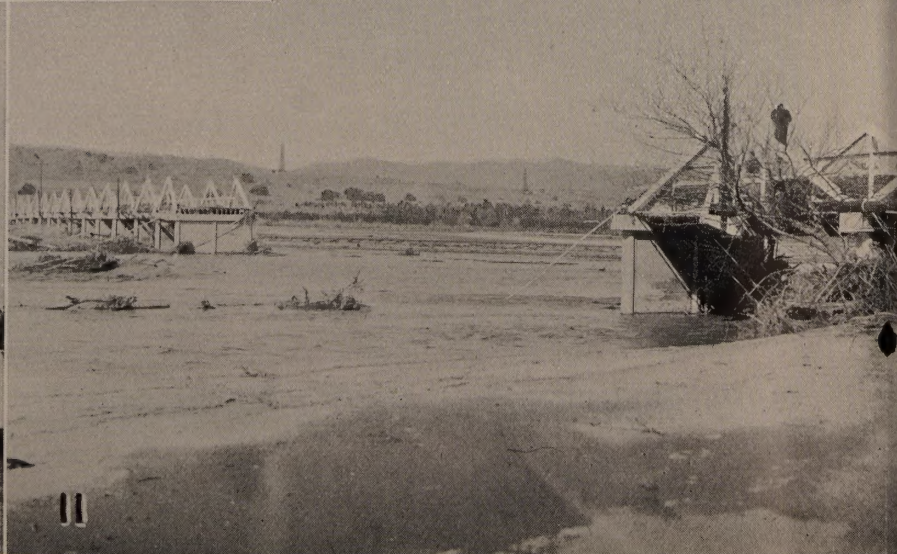
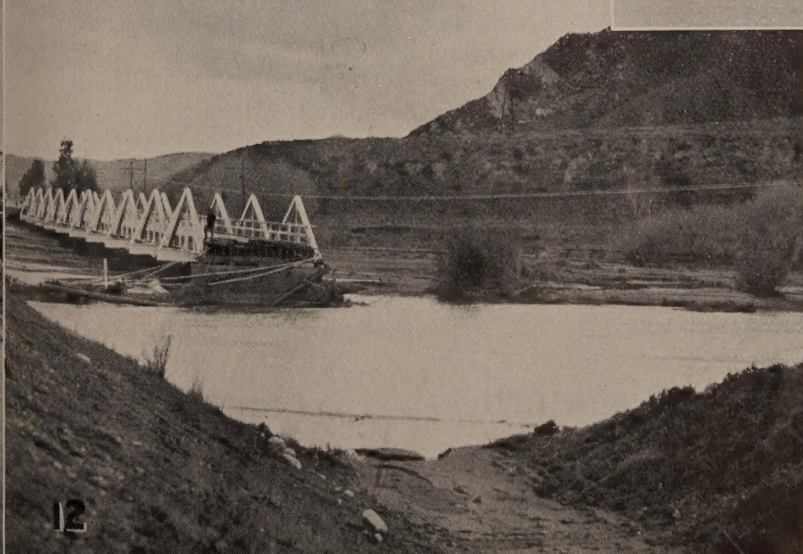
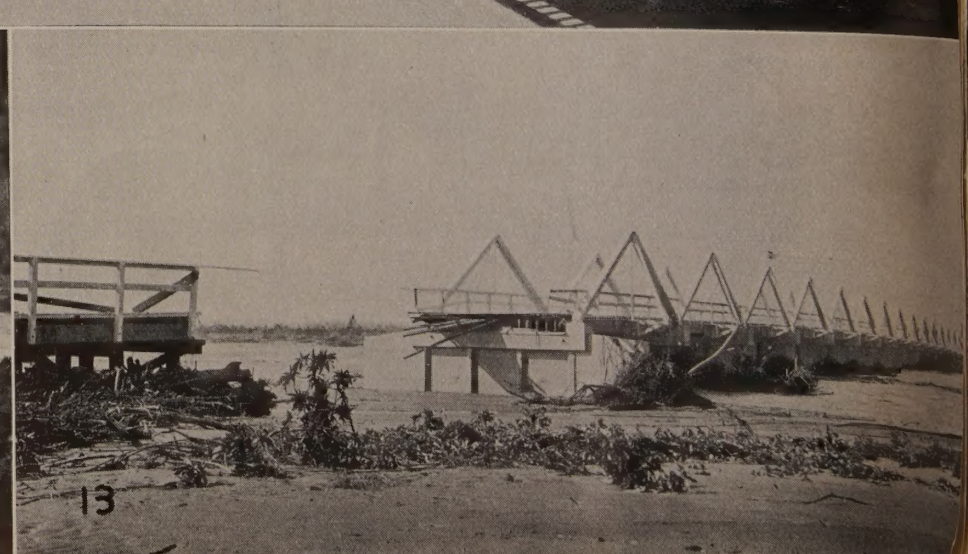
## BRIDGES HARD HIT BY FLOODS

- 1—San Antonio Creek Bridge, Ventura County.
- 2—Santa Clara River Bridge near Fillmore.
- 3—Wreckage of bridge across Santa Ana River, Orange County.
- 4—Santa Ana River Bridge east of Colton.
- 5—Sespe Creek Bridge east of Fillmore.
- 6—Big Tujunga Bridge, Los Angeles County.
- 7—Cujama Bridge, 20 miles east of Santa Maria.
- 8—Santa Clara River Bridge, Ventura County.
- 9—Bridge across Santa Ana River near Newport.
- 10—Bridge across Santa Ana River in Santa Ana.
- 11—Santa Ana River Bridge in Santa Ana Canyon.
- 12—Castaic Creek Bridge, Los Angeles County.
- 13—Santa Ana River Bridge near Olive, Orange County.

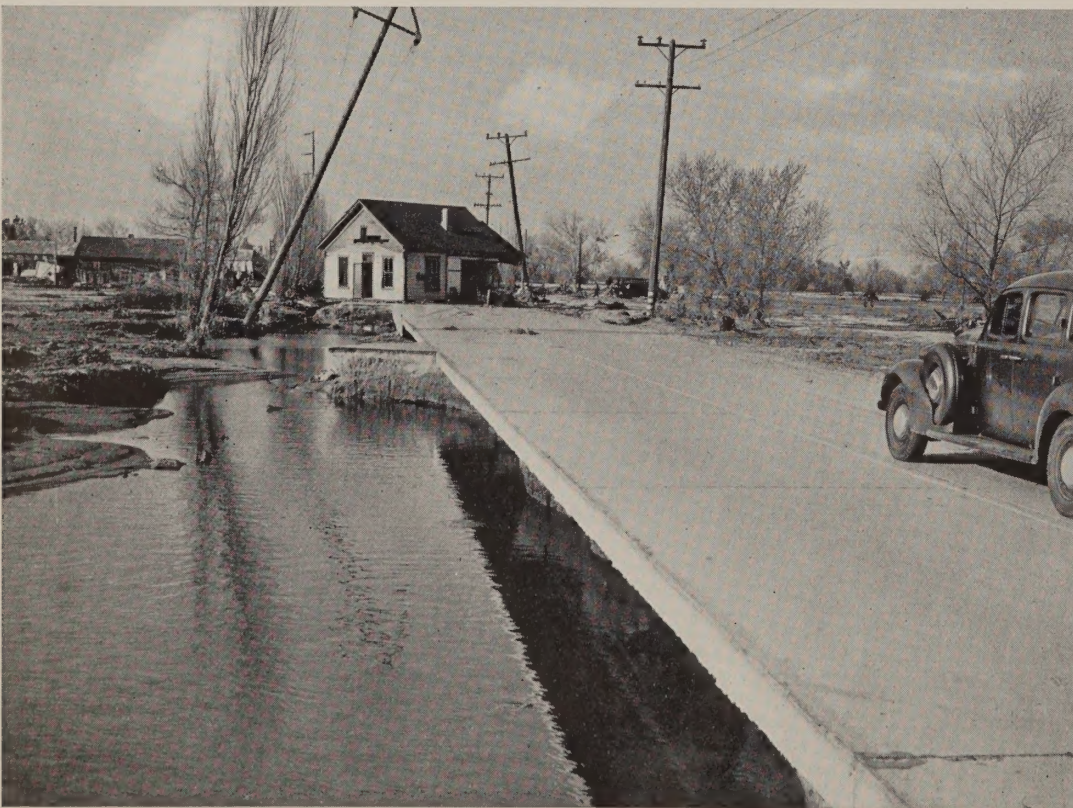
House washed onto highway on E Street near city limits of San Bernardino.
